GEOTECHNICAL INVESTIGATION

**PROPOSED SUBDIVISION
109 OLD PETERBOROUGH ROAD
PETERBOROUGH**

REPORT NO: 122818

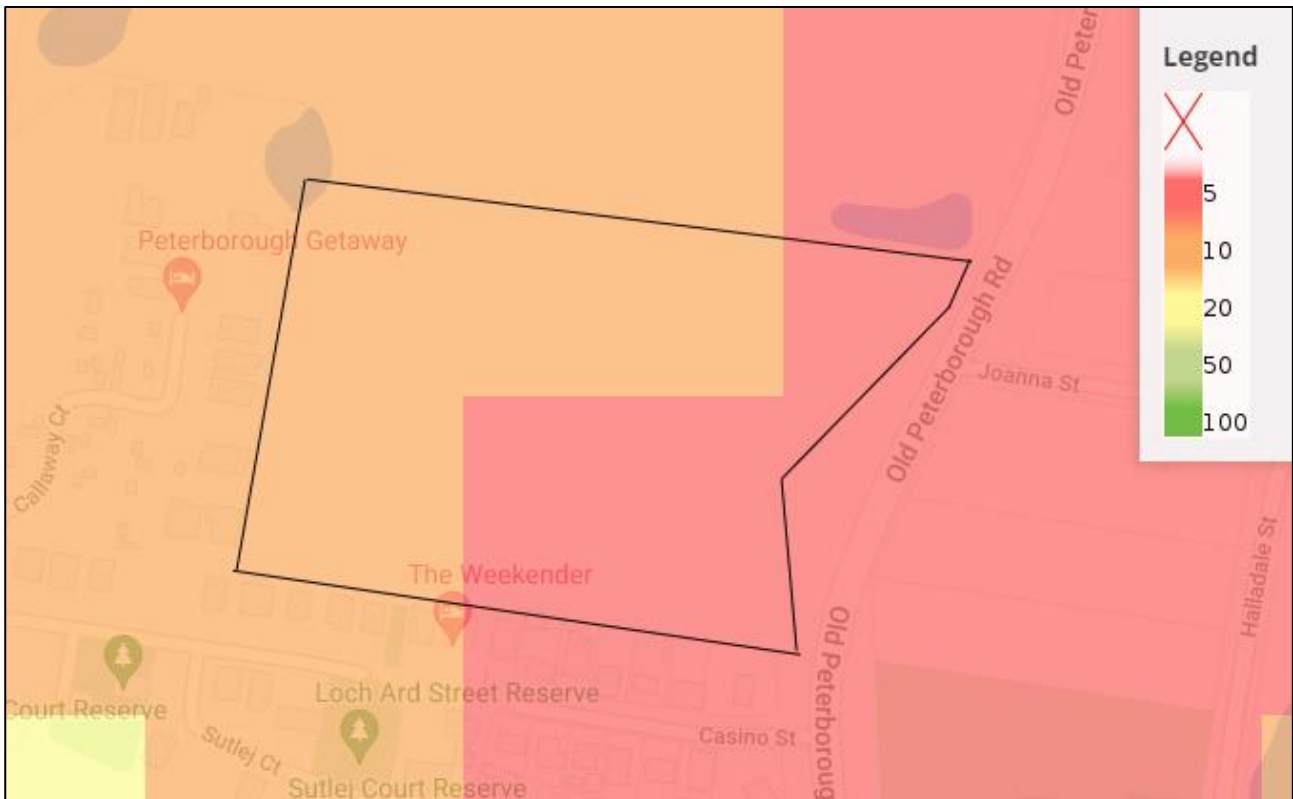
Figure 2: Ground Water Table

Visualising Victoria's Groundwater map portal was checked and reveals an approximate groundwater level is in the order of 5.0 – 10.0 metres below the ground surface level at the subject site and this appears in line with our borehole drilling results. Some variation could, however, be expected.

Visualising Victoria's Groundwater

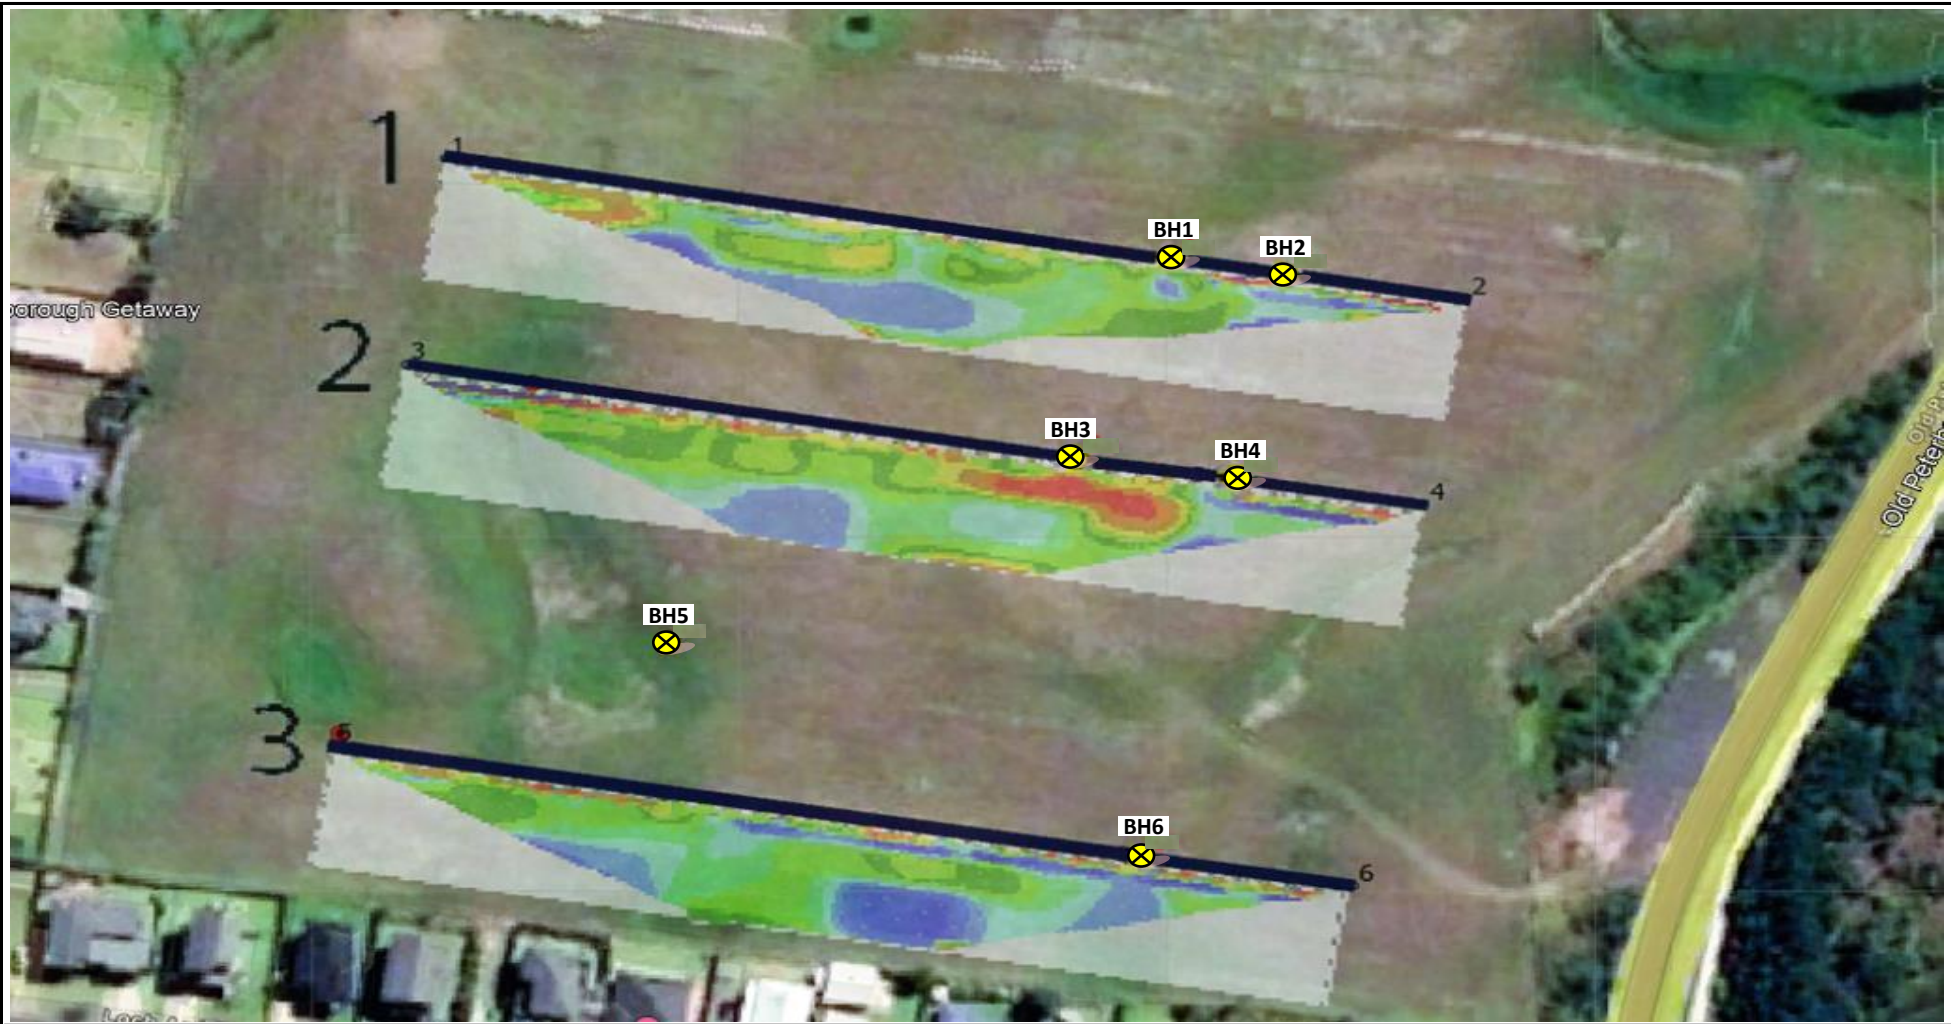
FIGURE 1

Denotes Approximate 6.0m Borehole Location (Boreholes 1 - 6)

BORE PLAN

Six (6) boreholes were drilled at the approximate locations as indicated on **Figure 1**, with these locations nominated by GPS ordinates. The logs of the boreholes, together with the result of in-situ vane shear strength and Standard Penetration testing carried out within the boreholes, are given on **Figures 2 - 7**.
